DEER PARK POND DAM (NJ 00502)

PHASE I INSPECTION REPORT
NATIONAL DAM SAFETY PROGRAM

REPT. NO. DAEN/NAP-53842/NJ00502-81/08

AUGUST 1981

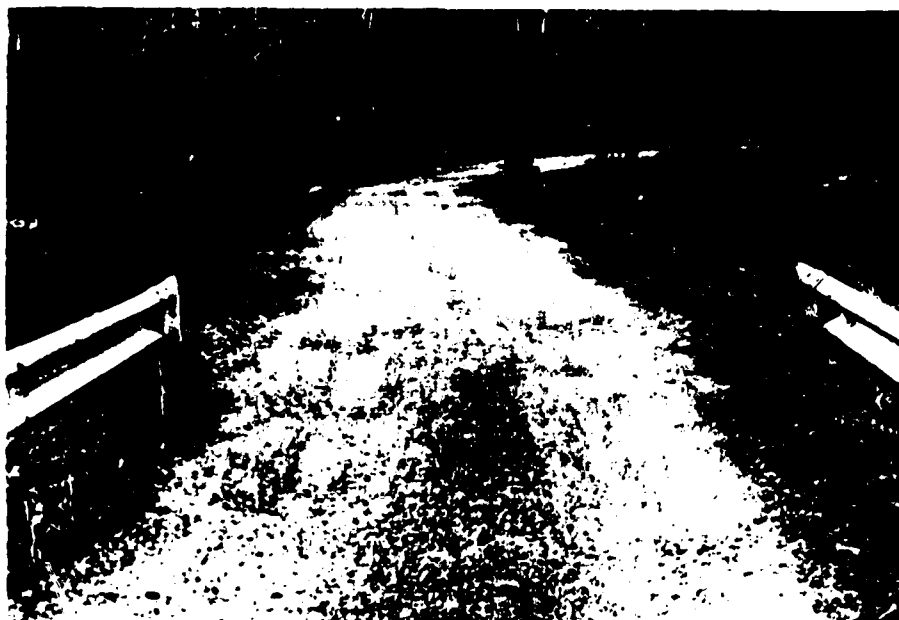
Two major depressions were observed to the right of the spillway bridge at the crest of the upstream slope. The depressions were approximately 3 to 5 feet in diameter and approximately 1-foot deep. Similarly several depressions and holes were observed on the crest of the dam to the left of the spillway bridge.

The crest of the dam is uneven. Although the cause of the unevenness cannot be determined on the basis of the visual inspection alone, it may be a sign of potential stability problems. The presence of several large depressions on the upstream slope near the crest could be an indication of internal erosion of the embankment which, if not stopped, could lead to breaching of the dam.

View of crest toward right abutment from center of spillway bridge.

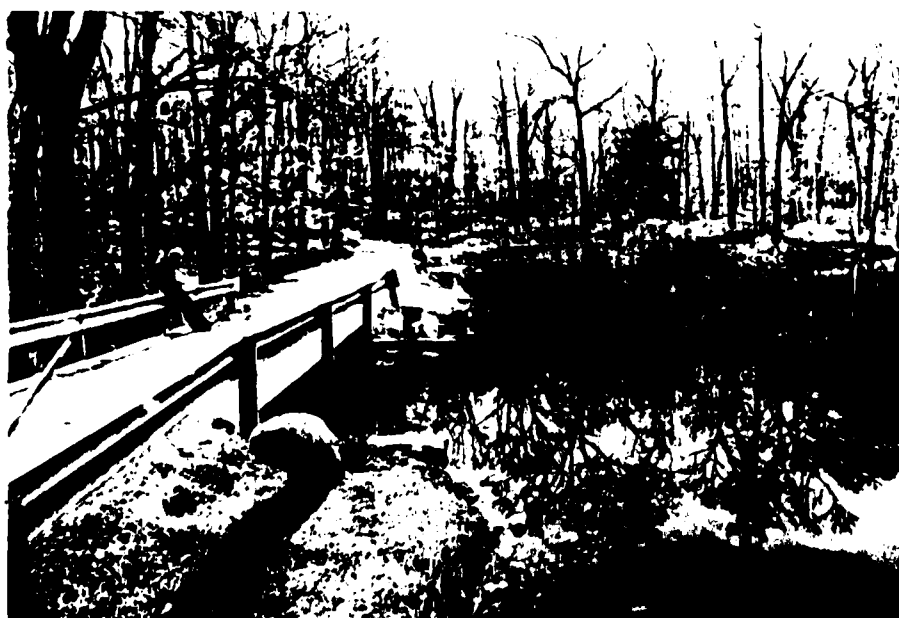
View looking along upstream side of dam and bridge over spillway. Note concrete training walls and apron leading to spillway crest under concrete-slab bridge.

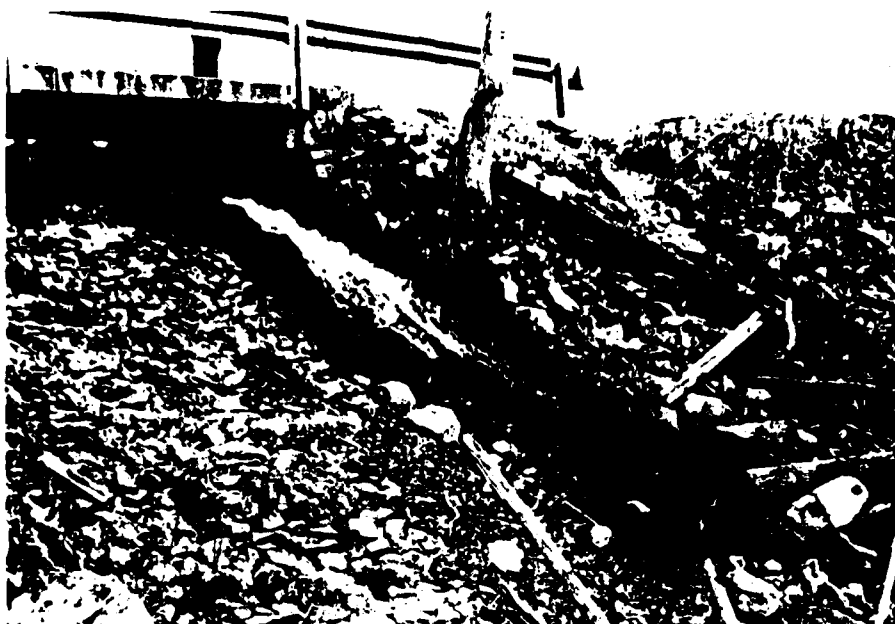
The erosion path, from the crest to the downstream toe of the embankment to the left of the spillway is susceptible to erosion and consequent damage to the embankment owing to both runoff of rainfall and overtopping, if the latter should occur.

View looking upstream at left side of spillway; note that water disappears into rock bottom at approximately the center of the photo. Note also erosion from trespassing below guard rail.

(3) Design and oversee repairs for the eroded area on the downstream slope to the left of the spillway.

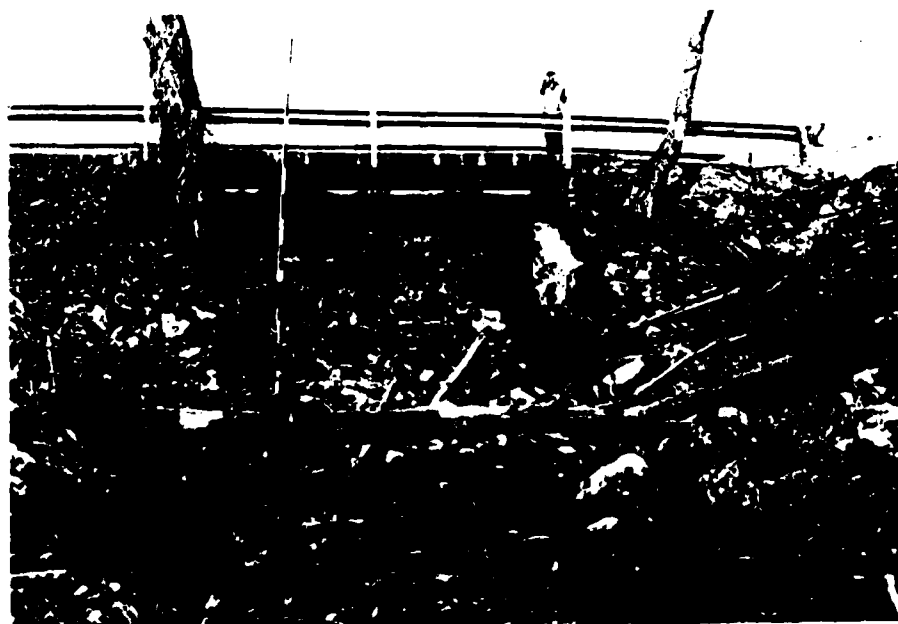
A 2.5-foot diameter tree is growing on the right spillway training wall just downstream from the crest of the spillway. Reservoir-bottom vegetation is partially blocking the entrance to the spillway. Considerable water was observed exiting underneath the spillway apron at the toe of the slope.

Surface is grouted loose rock - 3-inch - 6-inch in size. Much of the mortar is cracked. Water overflowing spillway crest is flowing into mortared rock face and exiting at the bottom. A few of the rocks are missing. Abutment walls are mortared stone masonry walls. Tree on right side has roots growing out into spillway surface. A little leakage noted 2 ft below crest exiting from abutment wall. Channel has boulders, debris and some fallen trees.

View looking at spillway crest and downstream face of spillway; note that water disappearing into bottom reappears at spillway toe.

Repair mortar and rock face. Remove tree and roots under proper supervision. Clear debris.

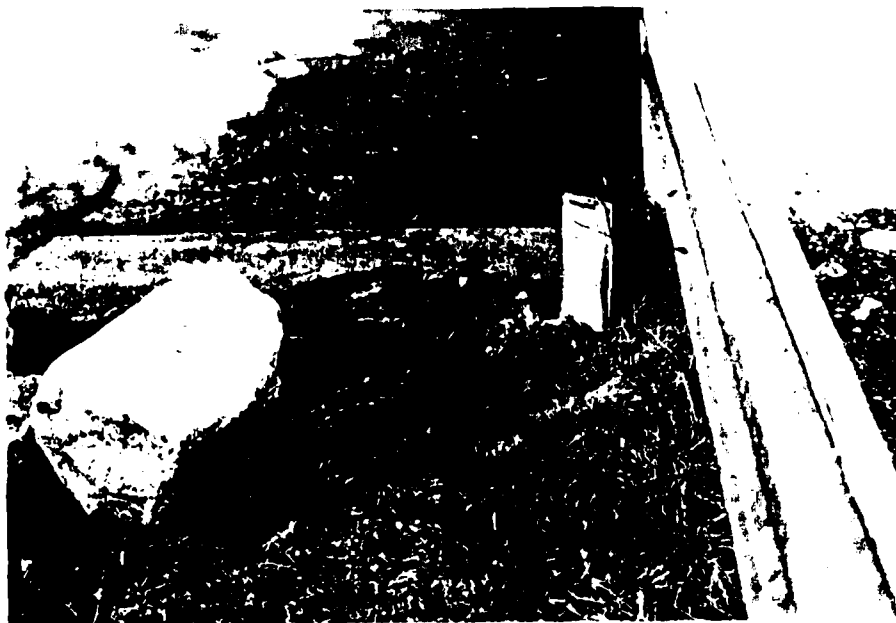
- (1) Ungated Spillway. The upstream concrete apron has two transverse cracks and the concrete training wall on the right side has separated approximately 1/2 inch from the bridge pier. Minor leakage was observed through the mortared masonry abutment wall approximately 2 feet below the crest.

View of right spillway training wall
on upstream side; note spalled concrete.

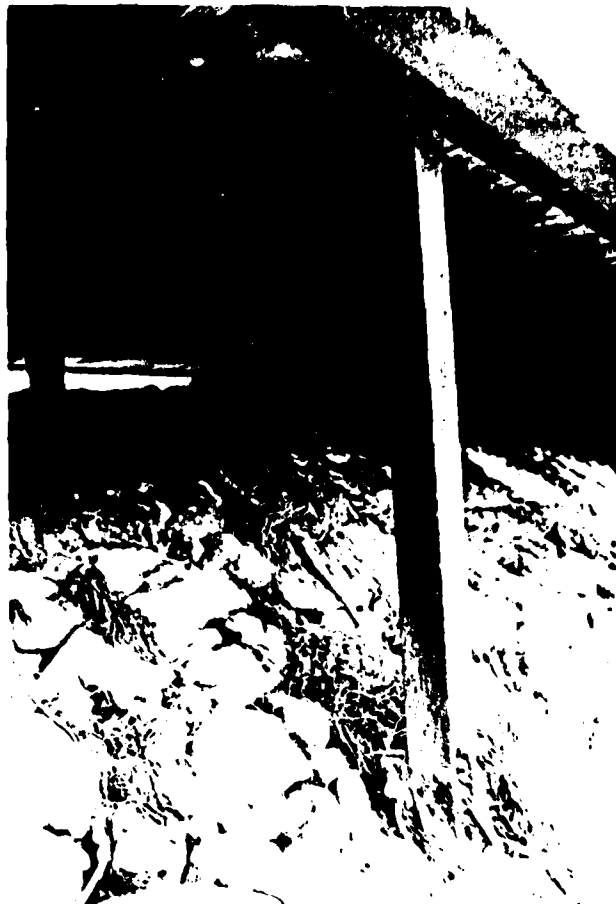
- (2) Service Bridge. The steel center supports are badly corroded at the bottom of each support providing very little support. Visible portions of bridge beams are badly rusted.
- (3) Low-Level Outlet. Two 12-inch cast iron pipes were observed at the toe of the spillway. However, no valves or inlet structure was observed at the time of inspection.

Poured concrete over wood deck. Deck surface in good condition. Some spalling at each end of deck. Both abutments in fair condition. Center support angles are badly corroded at the bottom - providing very little support. Visible portions of steel beams are badly rusted. Galvanized metal bridge railing - good condition.

View of underside of road bridge over spillway;
note that bridge column nearly rusted away at
footing.

(7) Design and oversee repairs to the service bridge steel beam and supports.

Investigate extent of corrosion and repair.

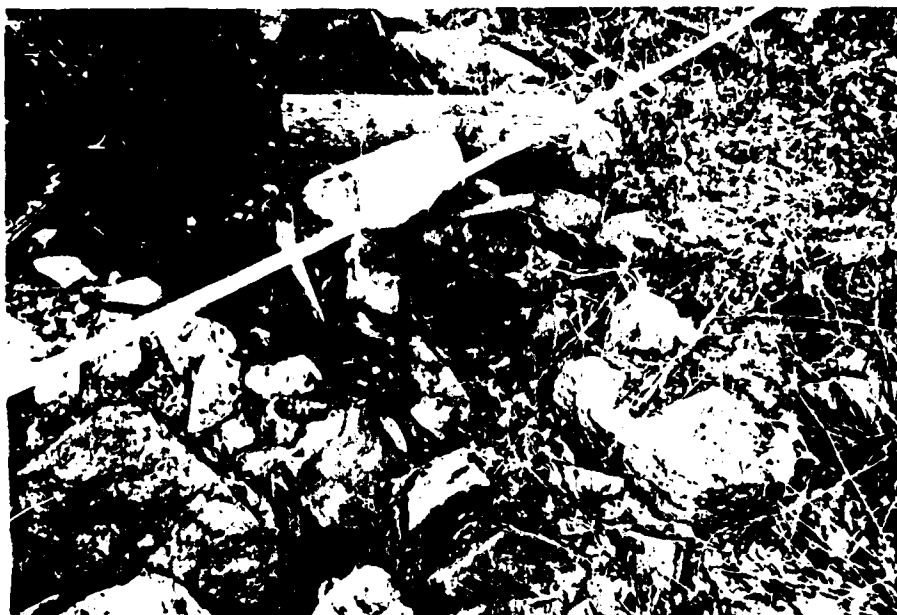
Outlet end of 12-inch cast iron pipe of low-level outlet under left side of downstream spillway face.

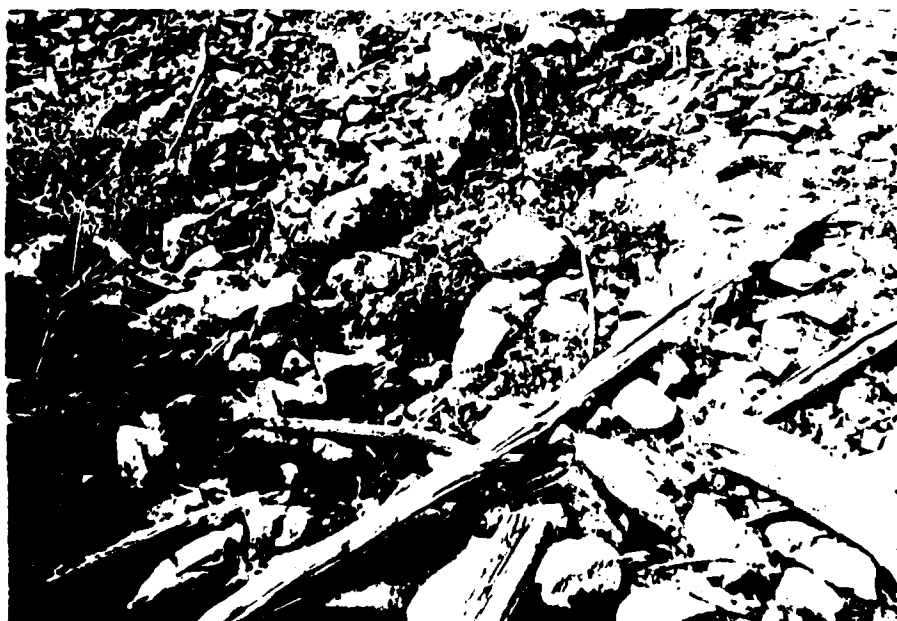
Outlet end of 12-inch cast iron pipe of low-level outlet under right side of downstream spillway face. (These pipes are 15 feet center to center.)
